Damage analysis of decorated surface structural support by the Acoustic Emission technique

Cappella XVII del Sacro Monte di Varallo

- (a) Indagine sulla stabilità degli intonaci affrescati e delle lesioni murarie con la tecnica EA
- (b) Analisi delle proprietà elettriche delle statue in terracotta

Risultati complessivi del monitoraggio condotto dal 28 aprile, ore 15.00, al 4 giugno, ore 12.00

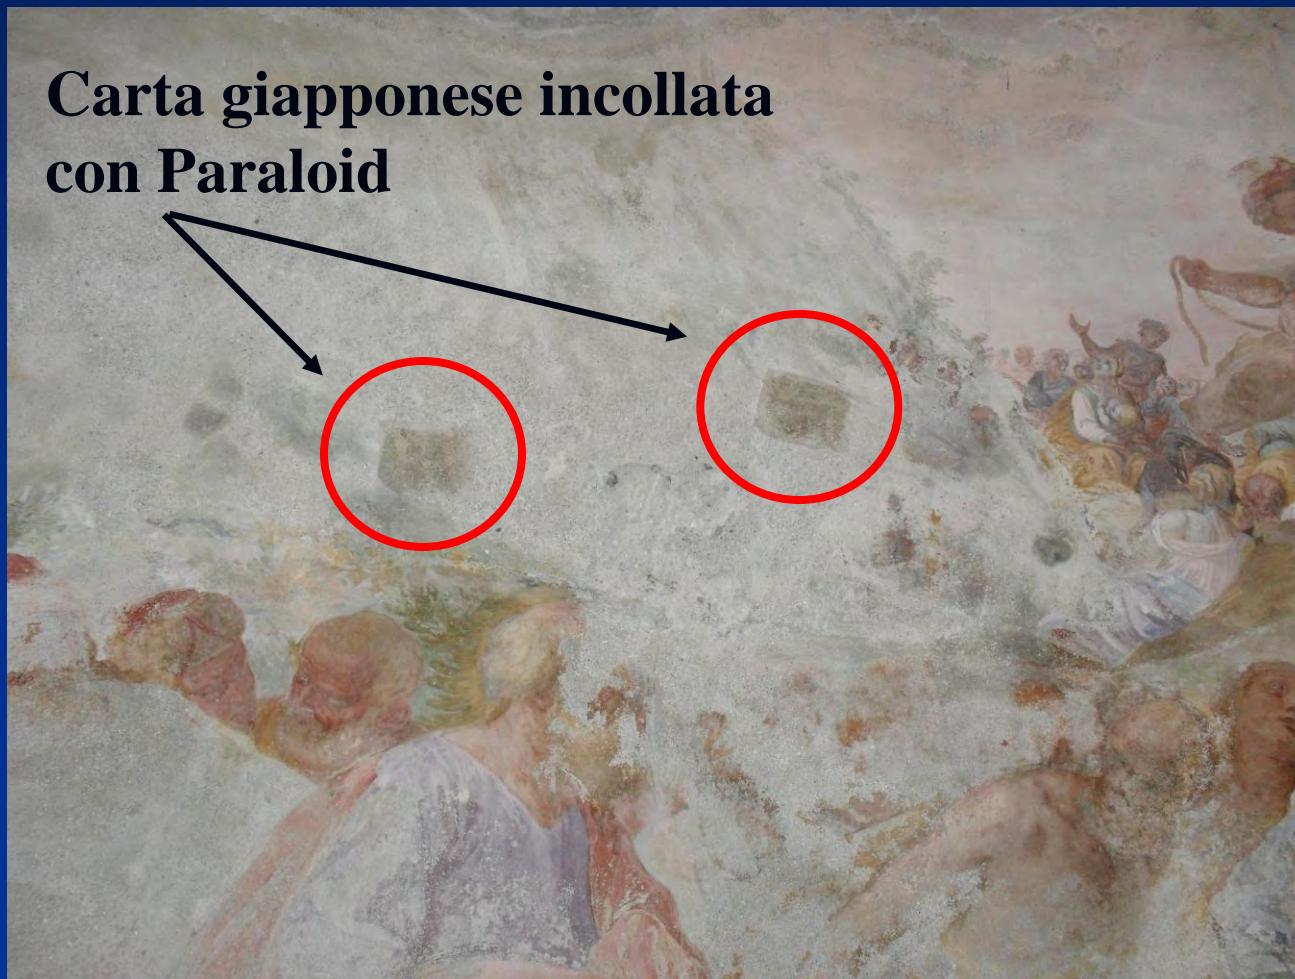
In particolare, il giorno 6 Aprile nelle zone da monitorare sono state predisposte delle pellicole di carta giapponese, sulla cui superficie è stata poi stesa una leggera mano di “Paraloid”.

Si tratta di una resina acrilica che viene utilizzata nel campo del restauro come consolidante a basse concentrazioni (2-4%), o come collante in concentrazioni maggiori.

Il Paraloid ha la funzione di formare una ottima base protettiva per il successivo incollaggio dei sensori EA.

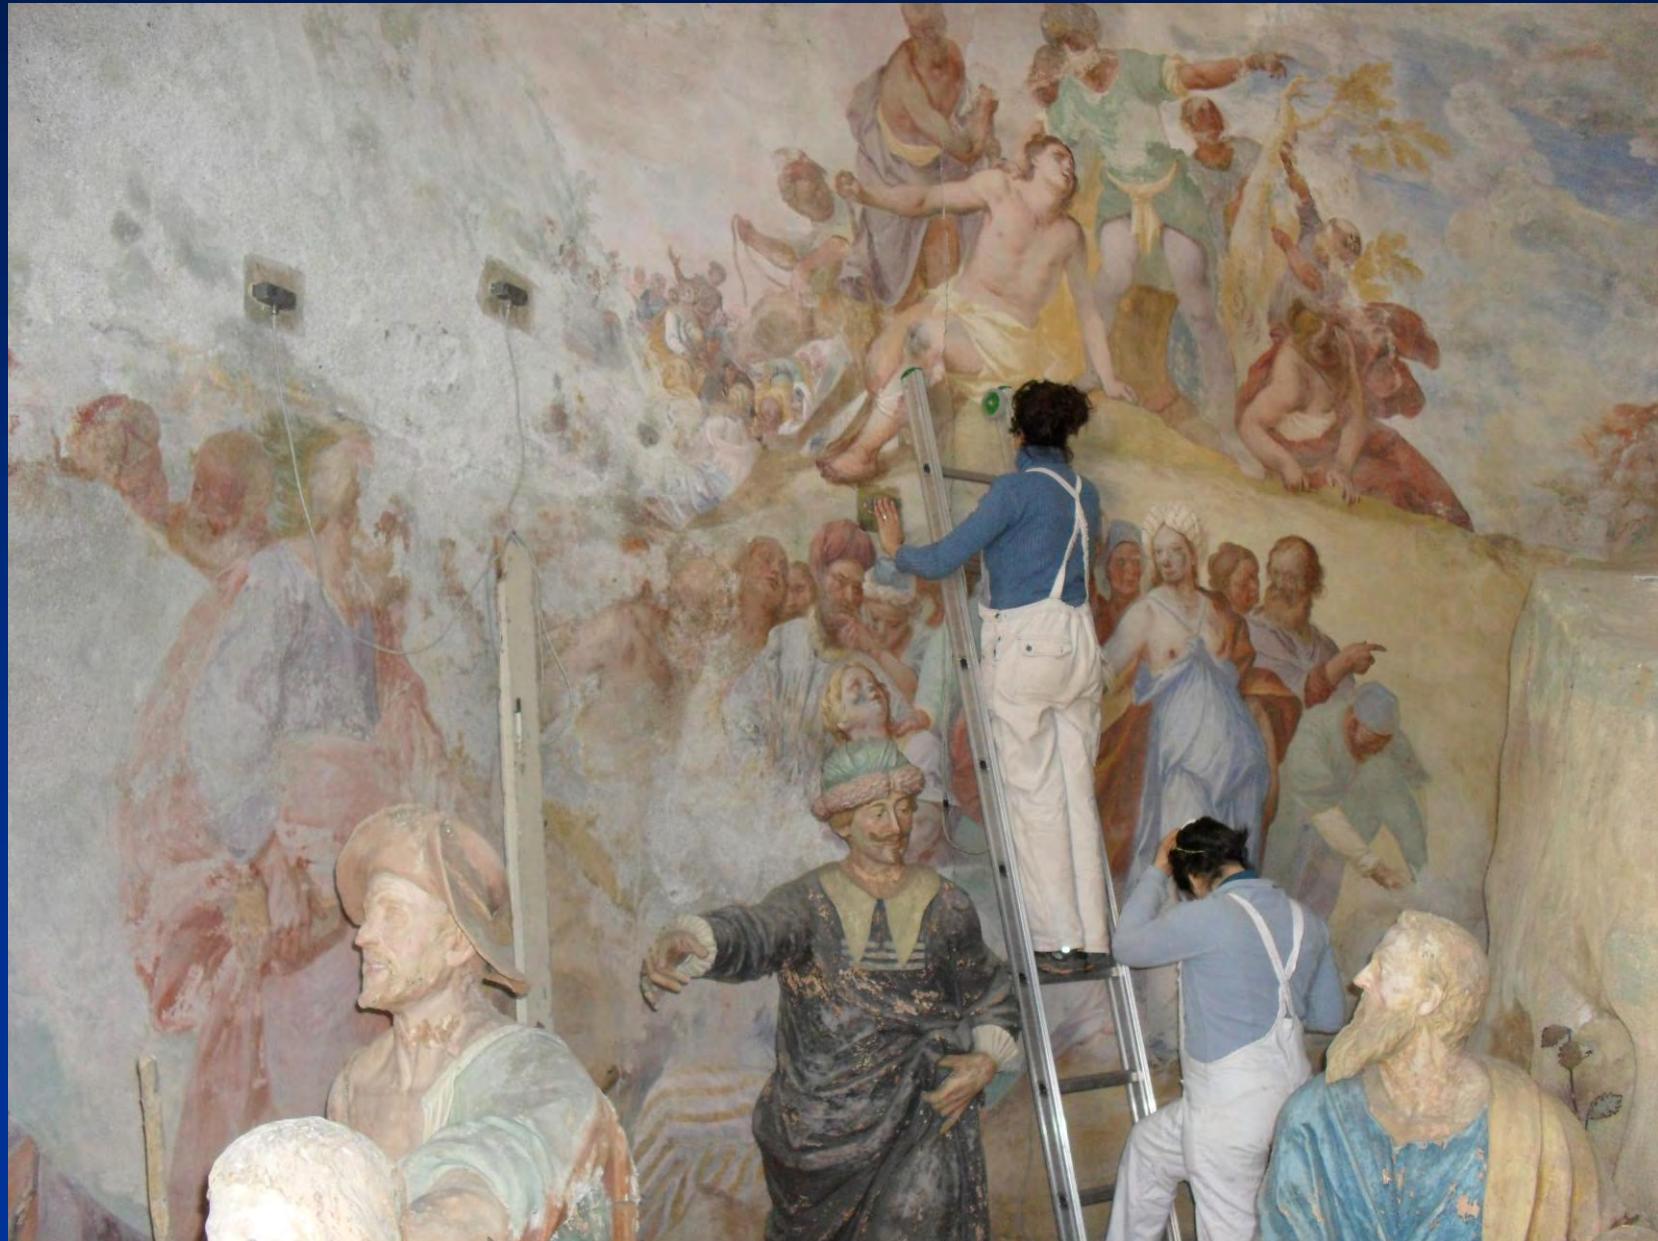
Sulle pellicole di carta giapponese sono quindi stati fissati i sensori EA mediante colla siliconica.

I sensori sono stati applicati in zone utili a monitorare contemporaneamente sia l'avanzamento della lesione che il distacco dell'intonaco.

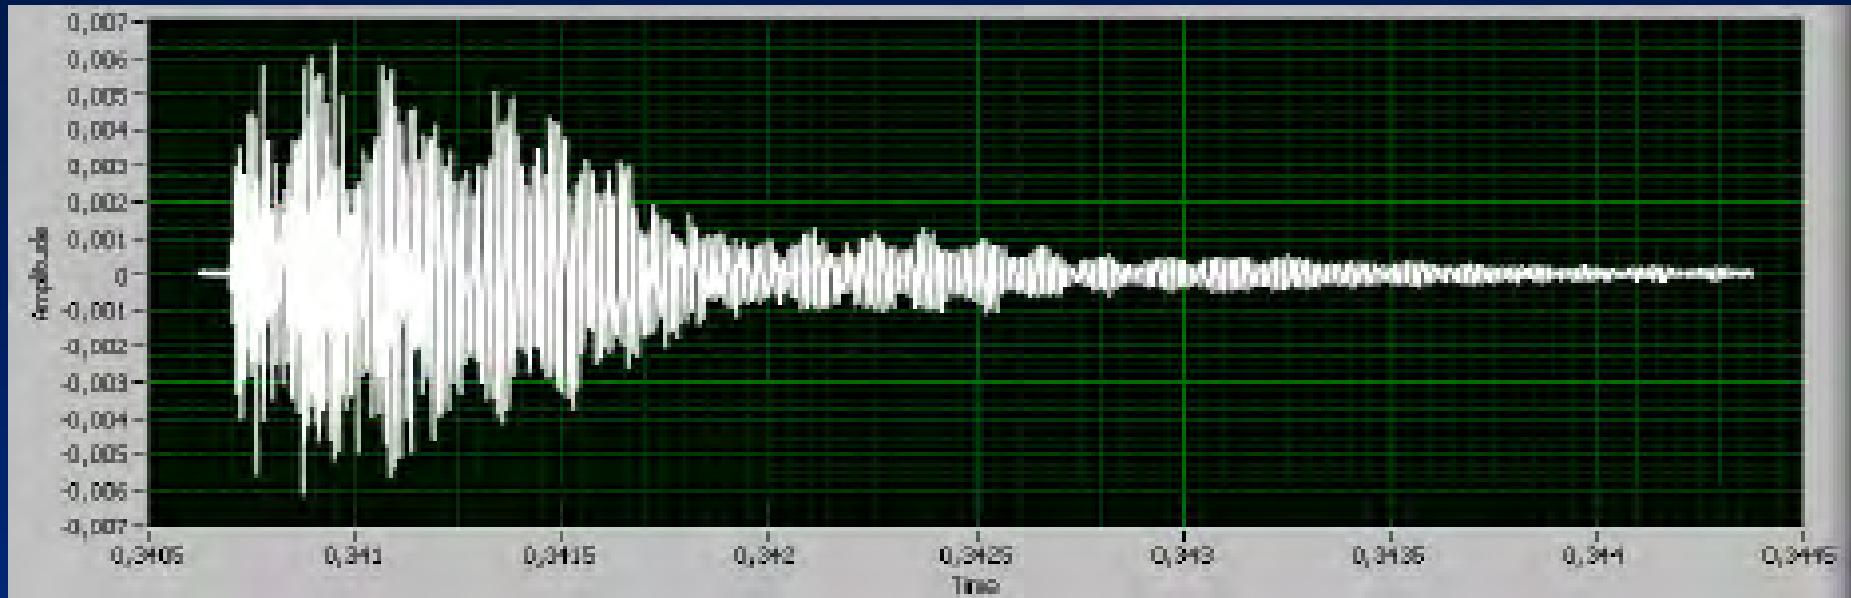
AE signal identified by sensor

The signal picked up by a transducer is preamplified and transformed into electric voltage.

It is then filtered to eliminate unwanted frequencies, such as the vibration arising from the mechanical instrumentation, which is generally lower than 50 kHz.

Up to this point the signal can be represented as a damped oscillation.

The signal is therefore analysed by a measuring system counting the emissions that exceed a certain voltage threshold measured in volts (V).

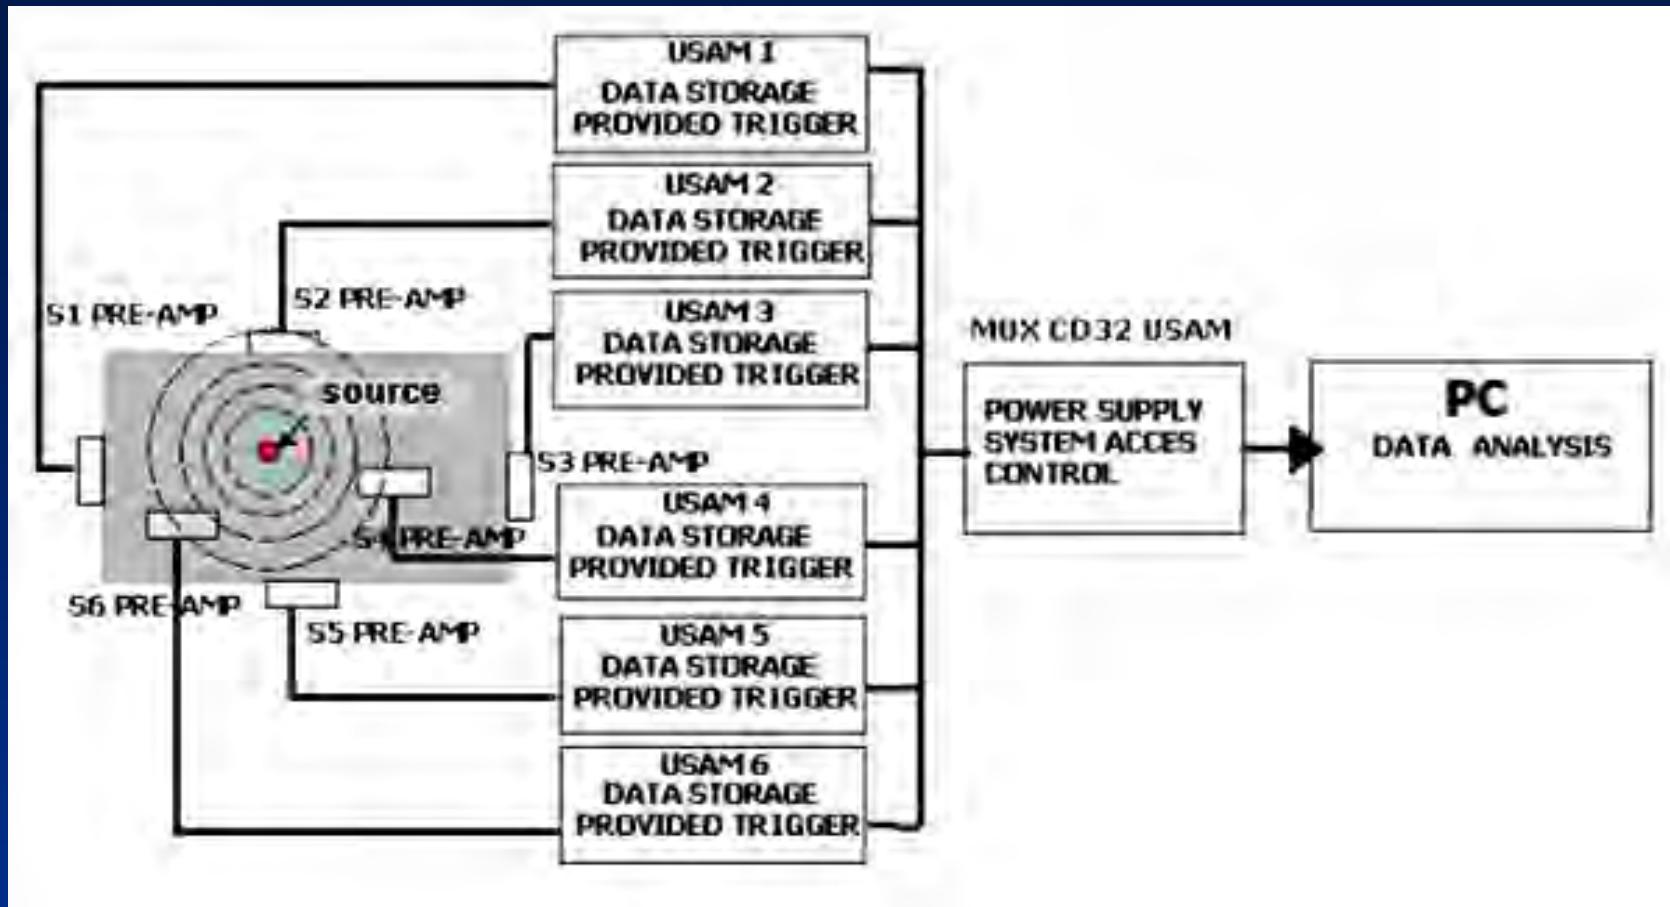
AE Data acquisition system - USAM units

- PZT transducers are set on a frequency range between 50 kHz and 800 kHz.
- Data acquisition system consisting in: 6 Pre-Amplified sensors, 6 Data storage provided trigger, a central unit for the synchronization phase, a threshold measurer.
- From this elaboration microcracks localisation is performed and the condition of the monitored specimen can be determined.

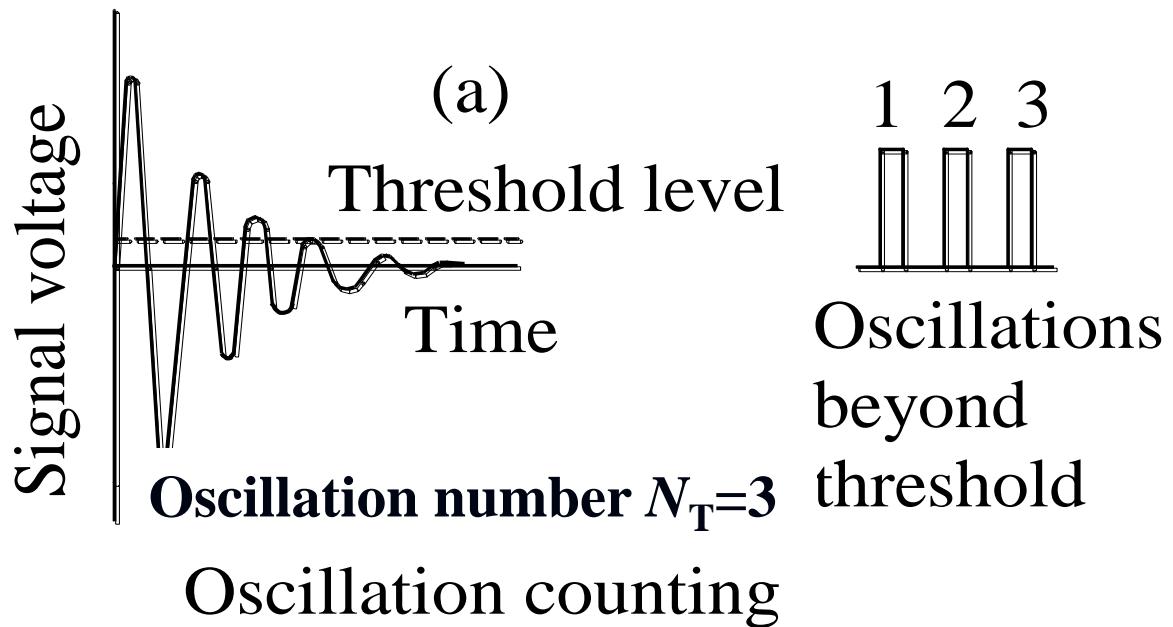
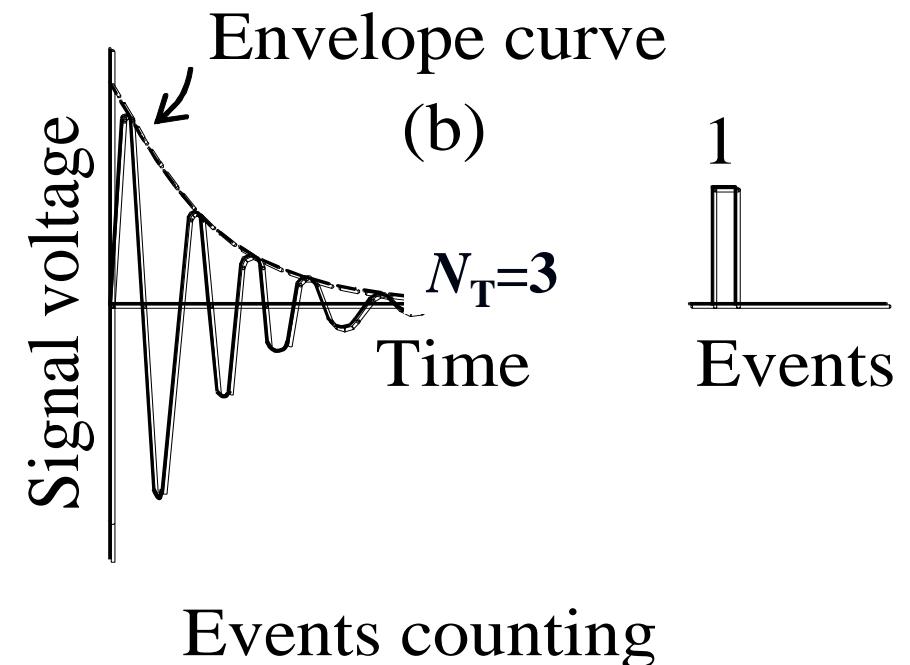
AE counting method

- The event intensity is measured by the oscillation number N_T
- The oscillation number N_T increases with the signal amplitude

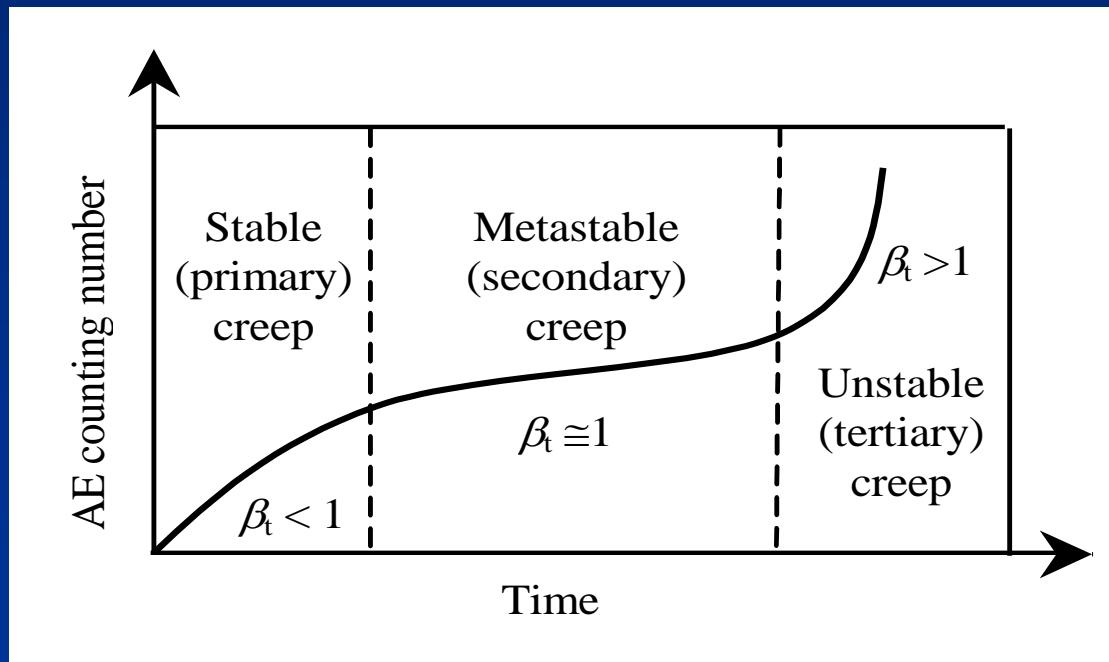
Pseudo-creep behaviour

Schematic plot of the AE counting number vs. time

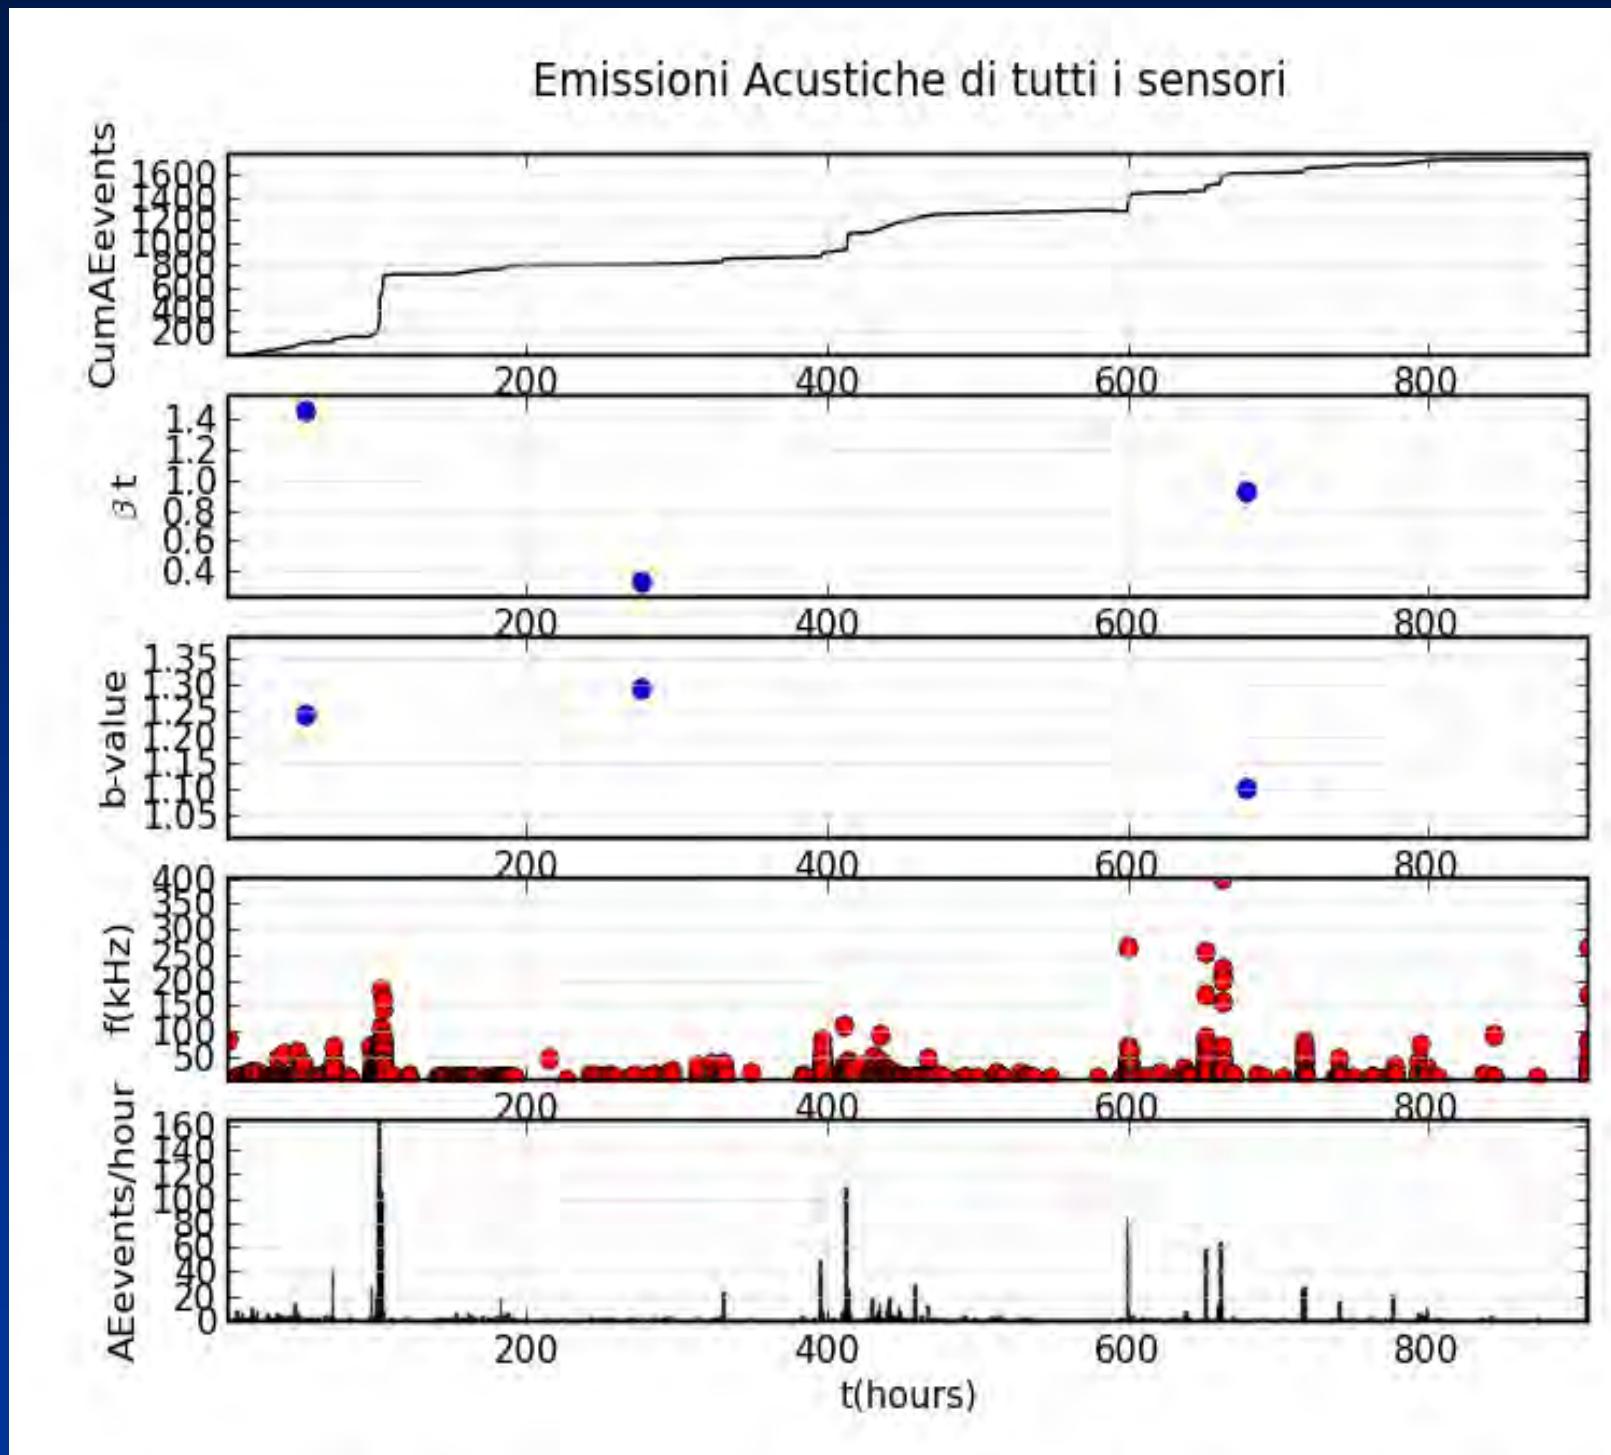
$$0.3 < \beta_t < 1.4$$

$$1.10 < b < 1.30$$

microfratture

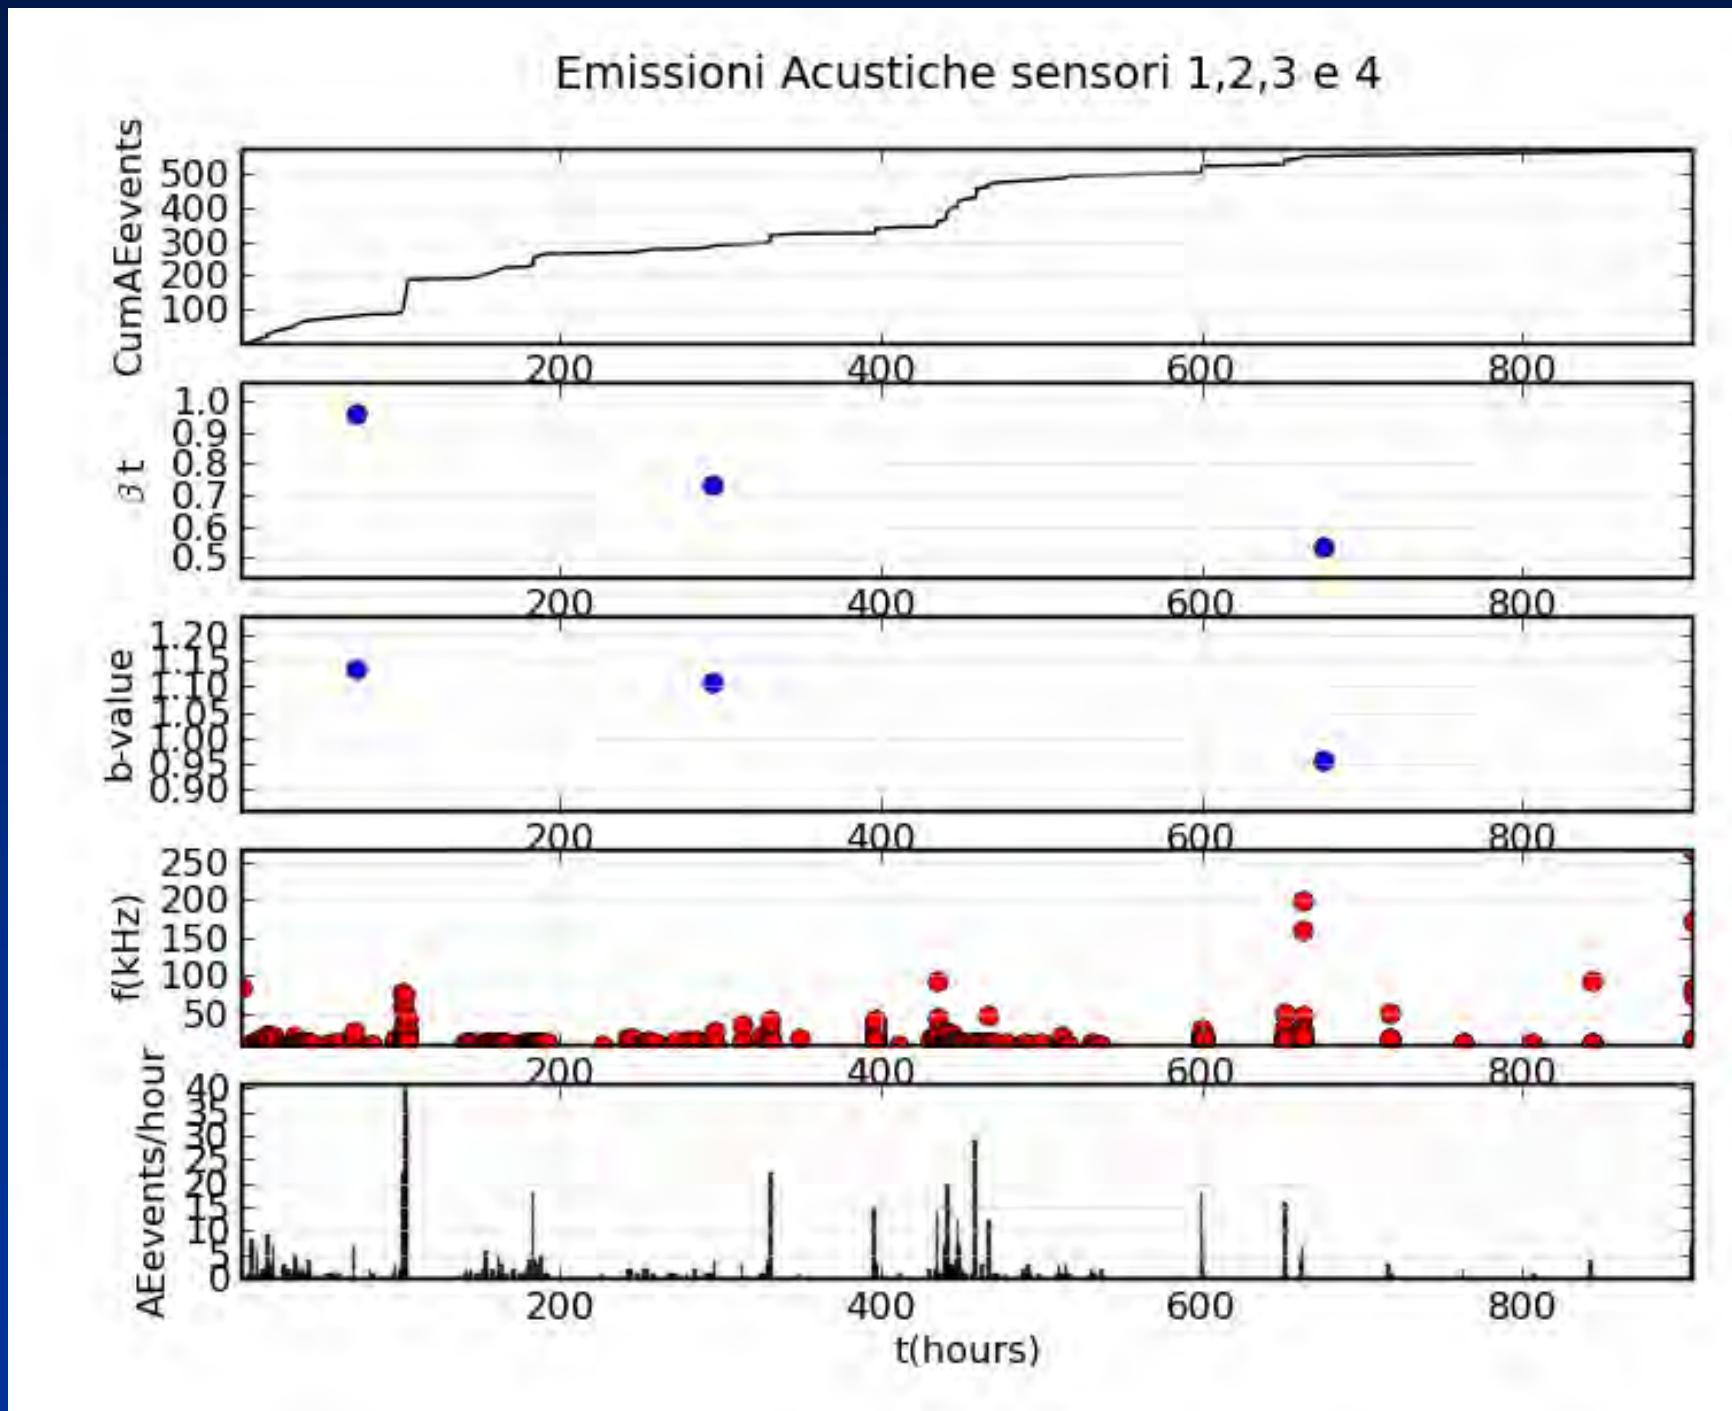
Risultati ottenuti dai sensori AE applicati nei pressi della lesione verticale

$$0.5 < \beta_t < 1.0$$

$$0.95 < b < 1.15$$

bassa frequenza

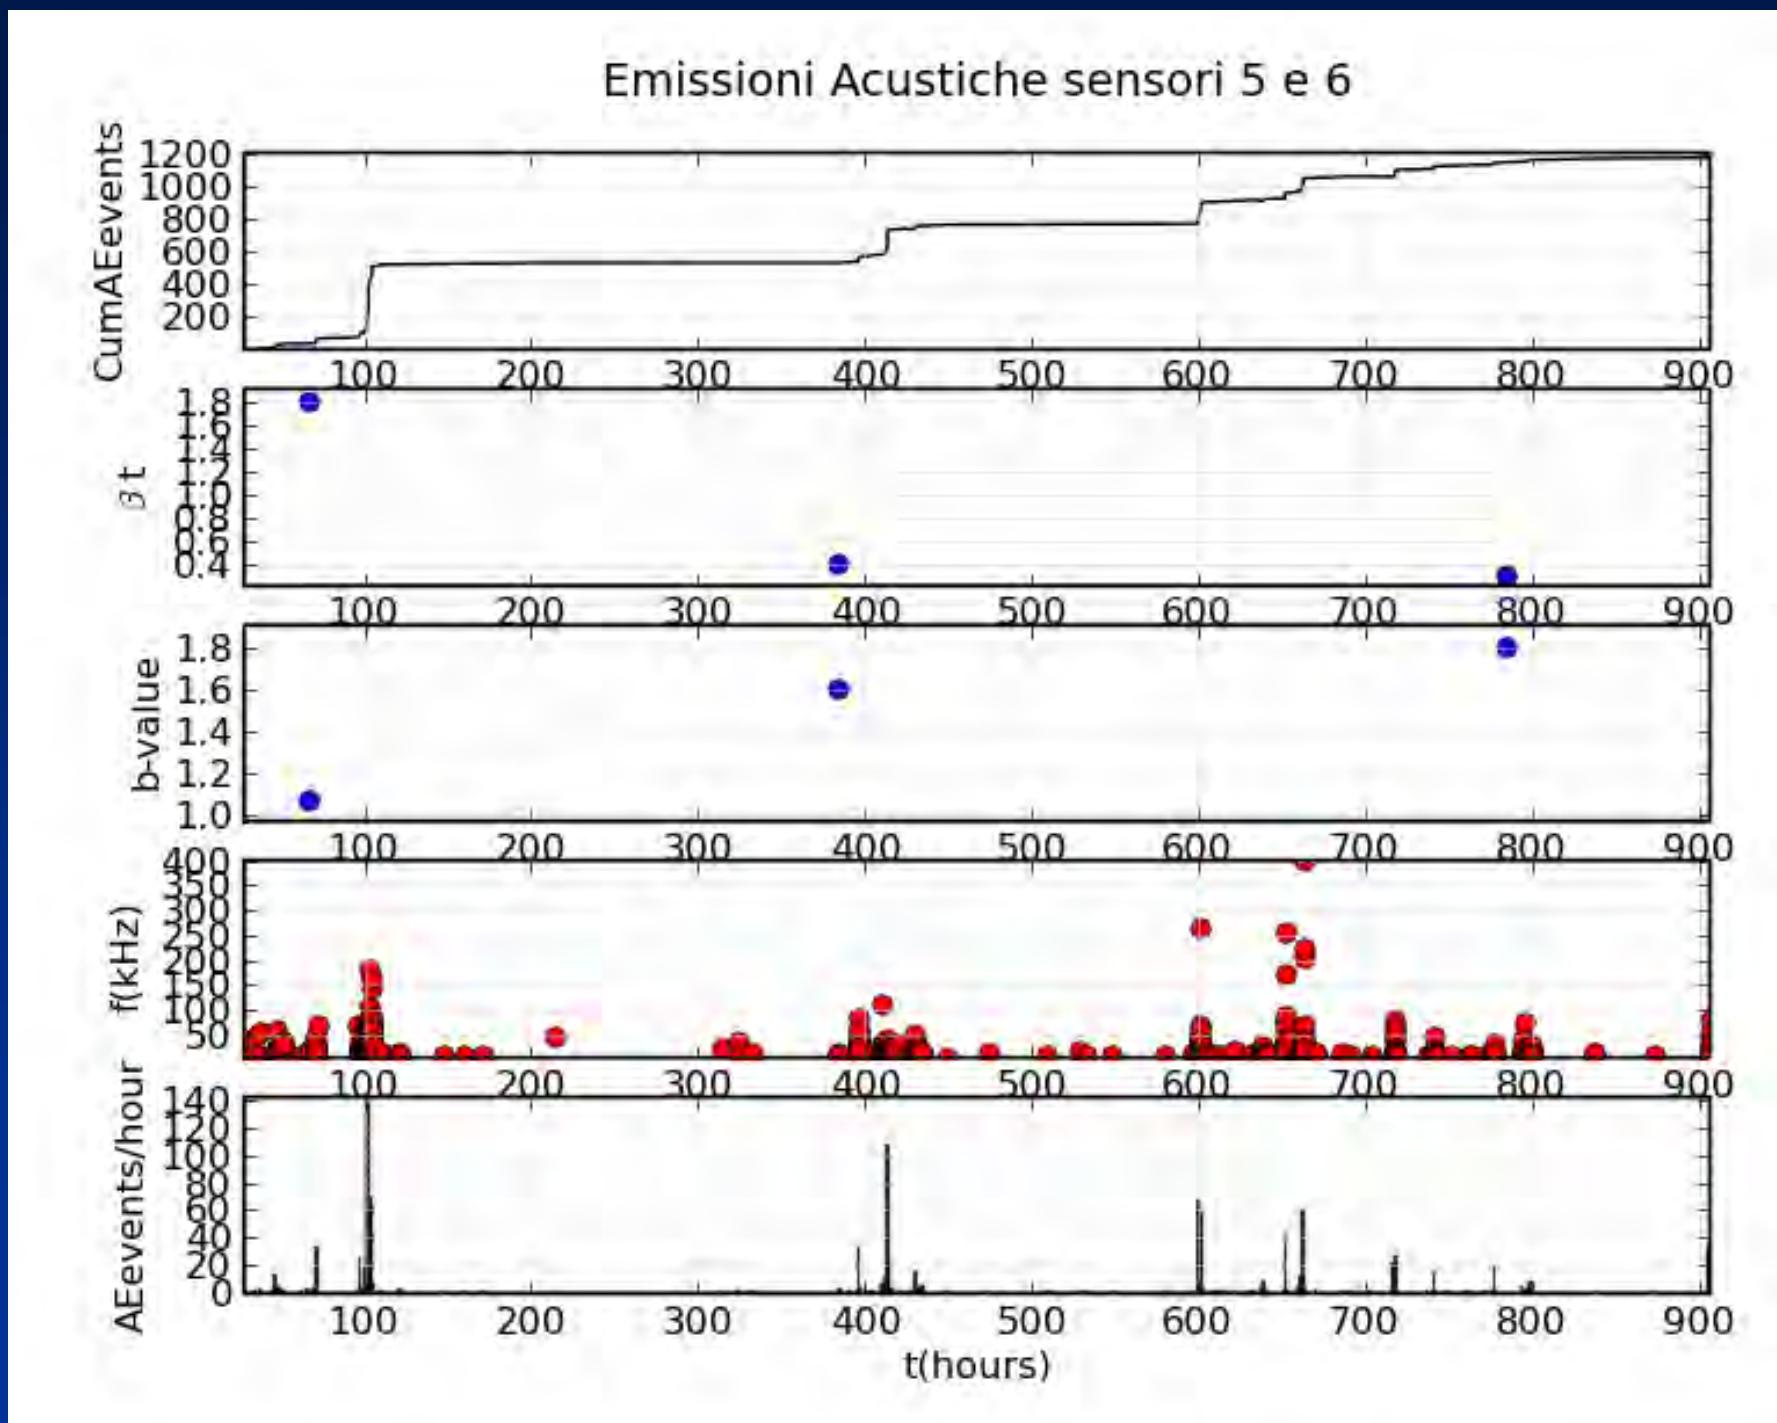
Risultati ottenuti dai sensori AE applicati nei pressi del distacco dell'intonaco

$$0.5 < \beta_t < 1.8$$

$$1.10 < b < 1.80$$

alta frequenza

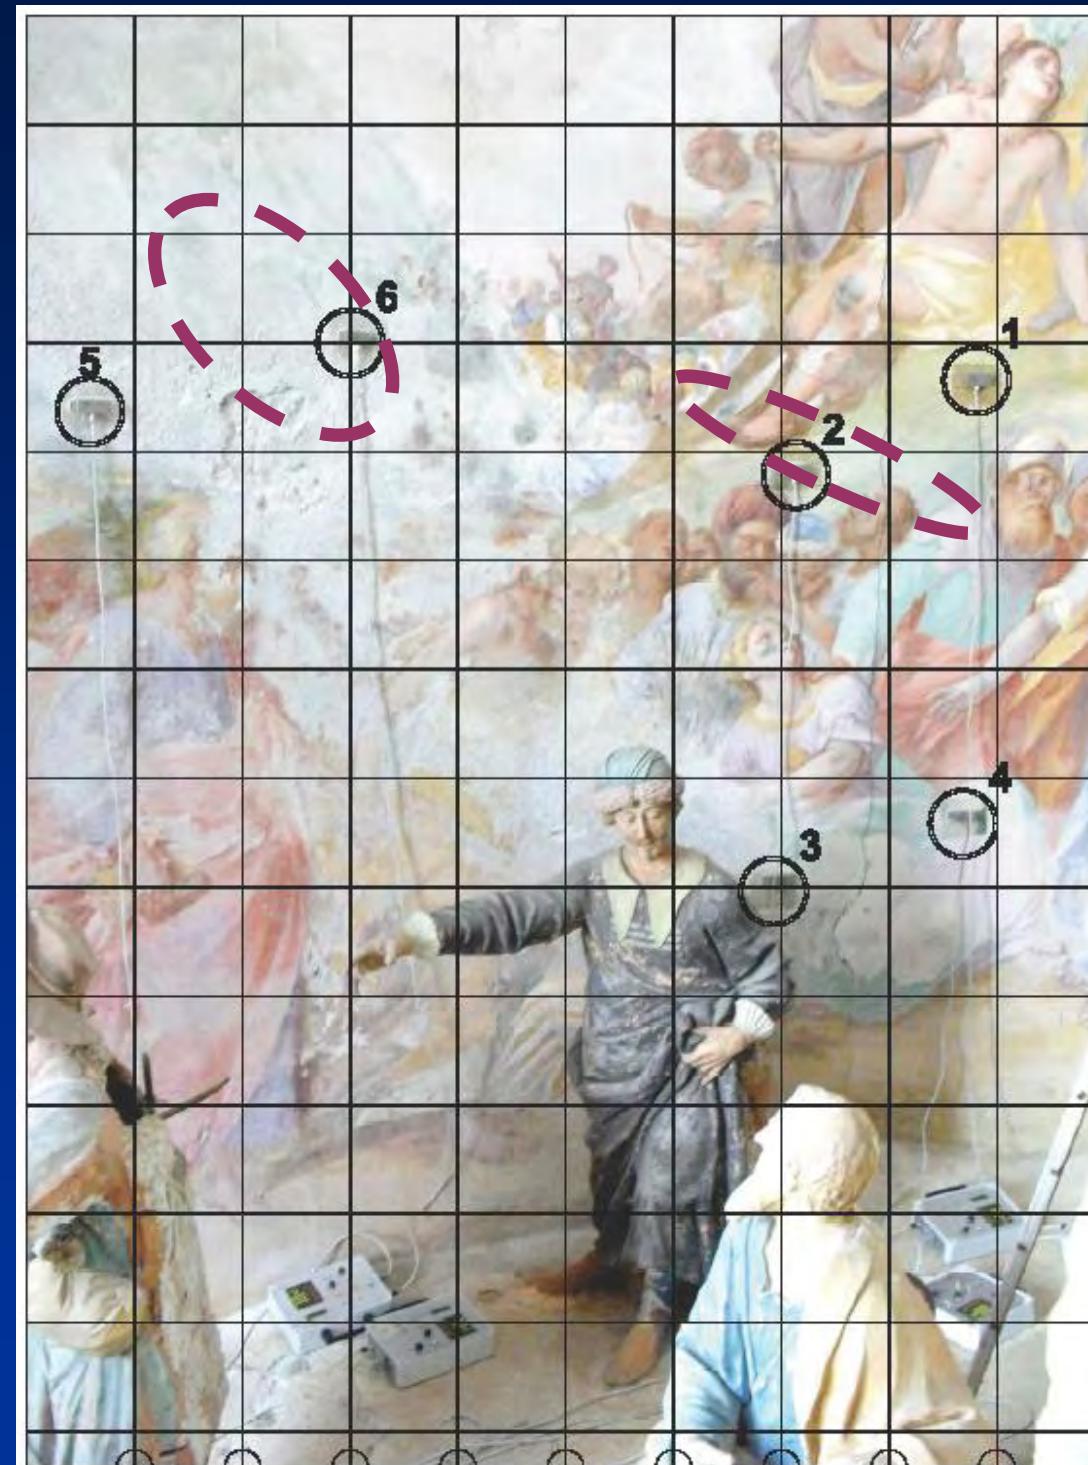
Numerazione dei sensori e localizzazione delle sorgenti di Emissione Acustica

Regioni di
localizzazione dei
segnali EA

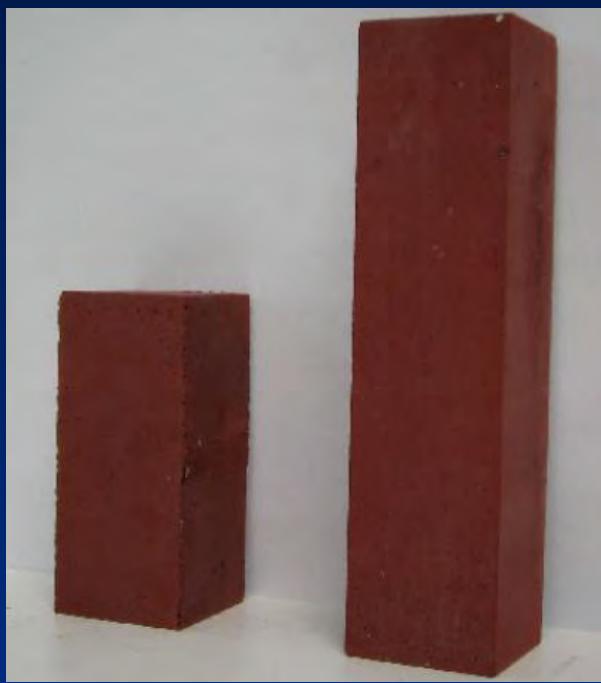
C1-C2

C1-C4: Prismatic mortar specimens enriched with 10% of iron dioxide.

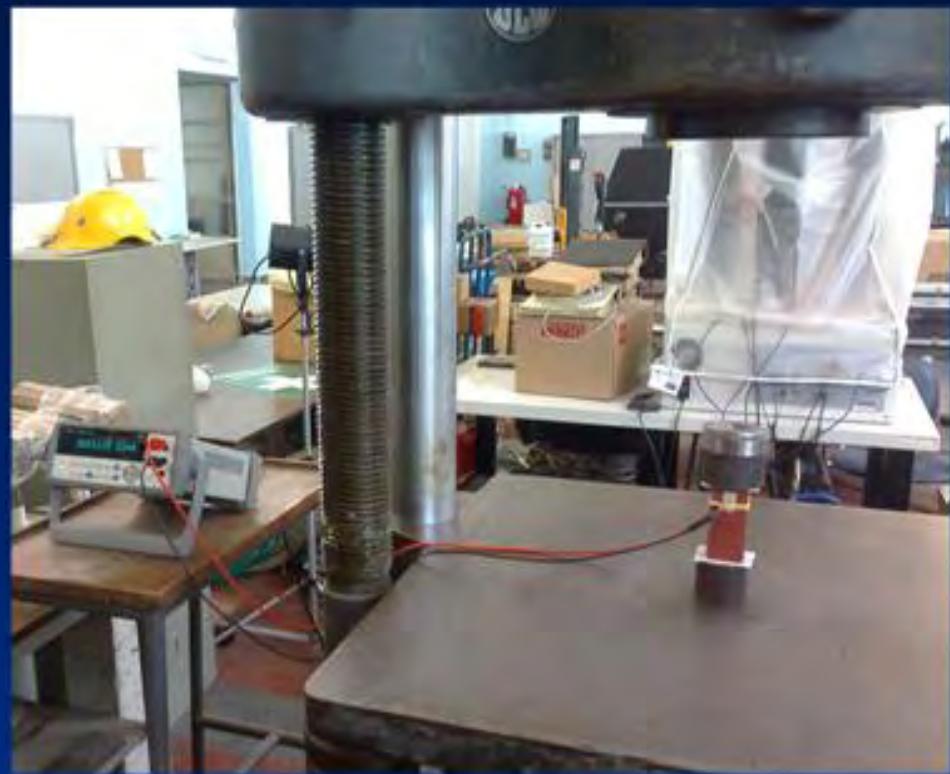
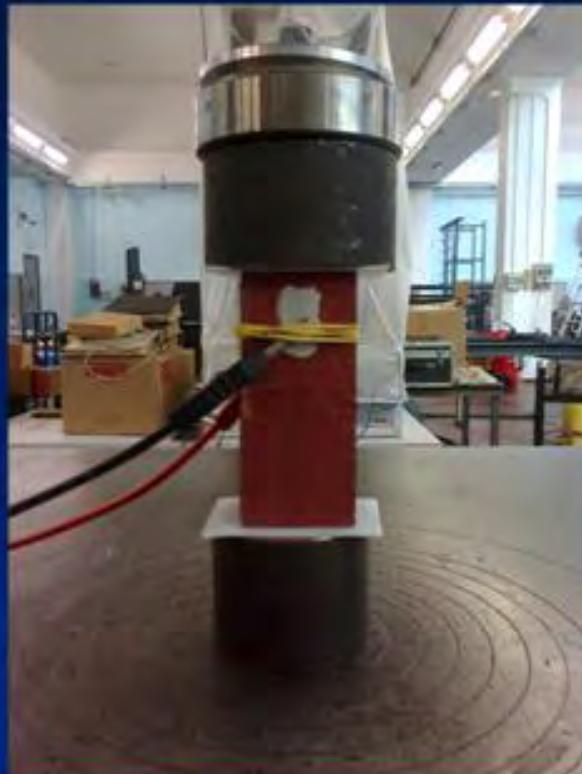
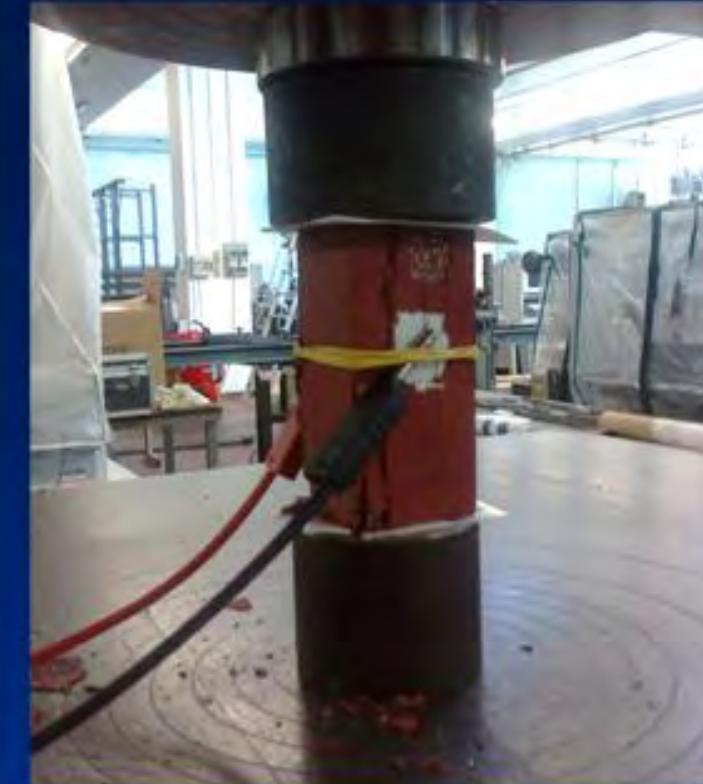
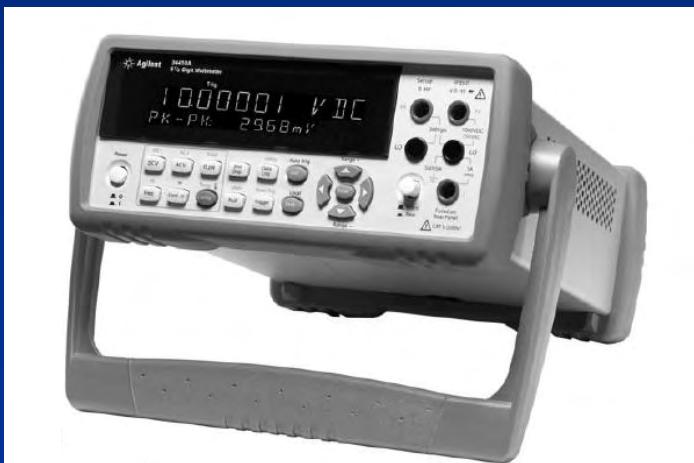
Experimental setup

Using an Agilent model 34411A multimeter detector, for all the specimens, at the beginning of each compression test, the initial electrical resistance R_0 was evaluated.

Afterwards the resistance variation R was monitored until the final collapse, calculating the relative ratio R/R_0 .

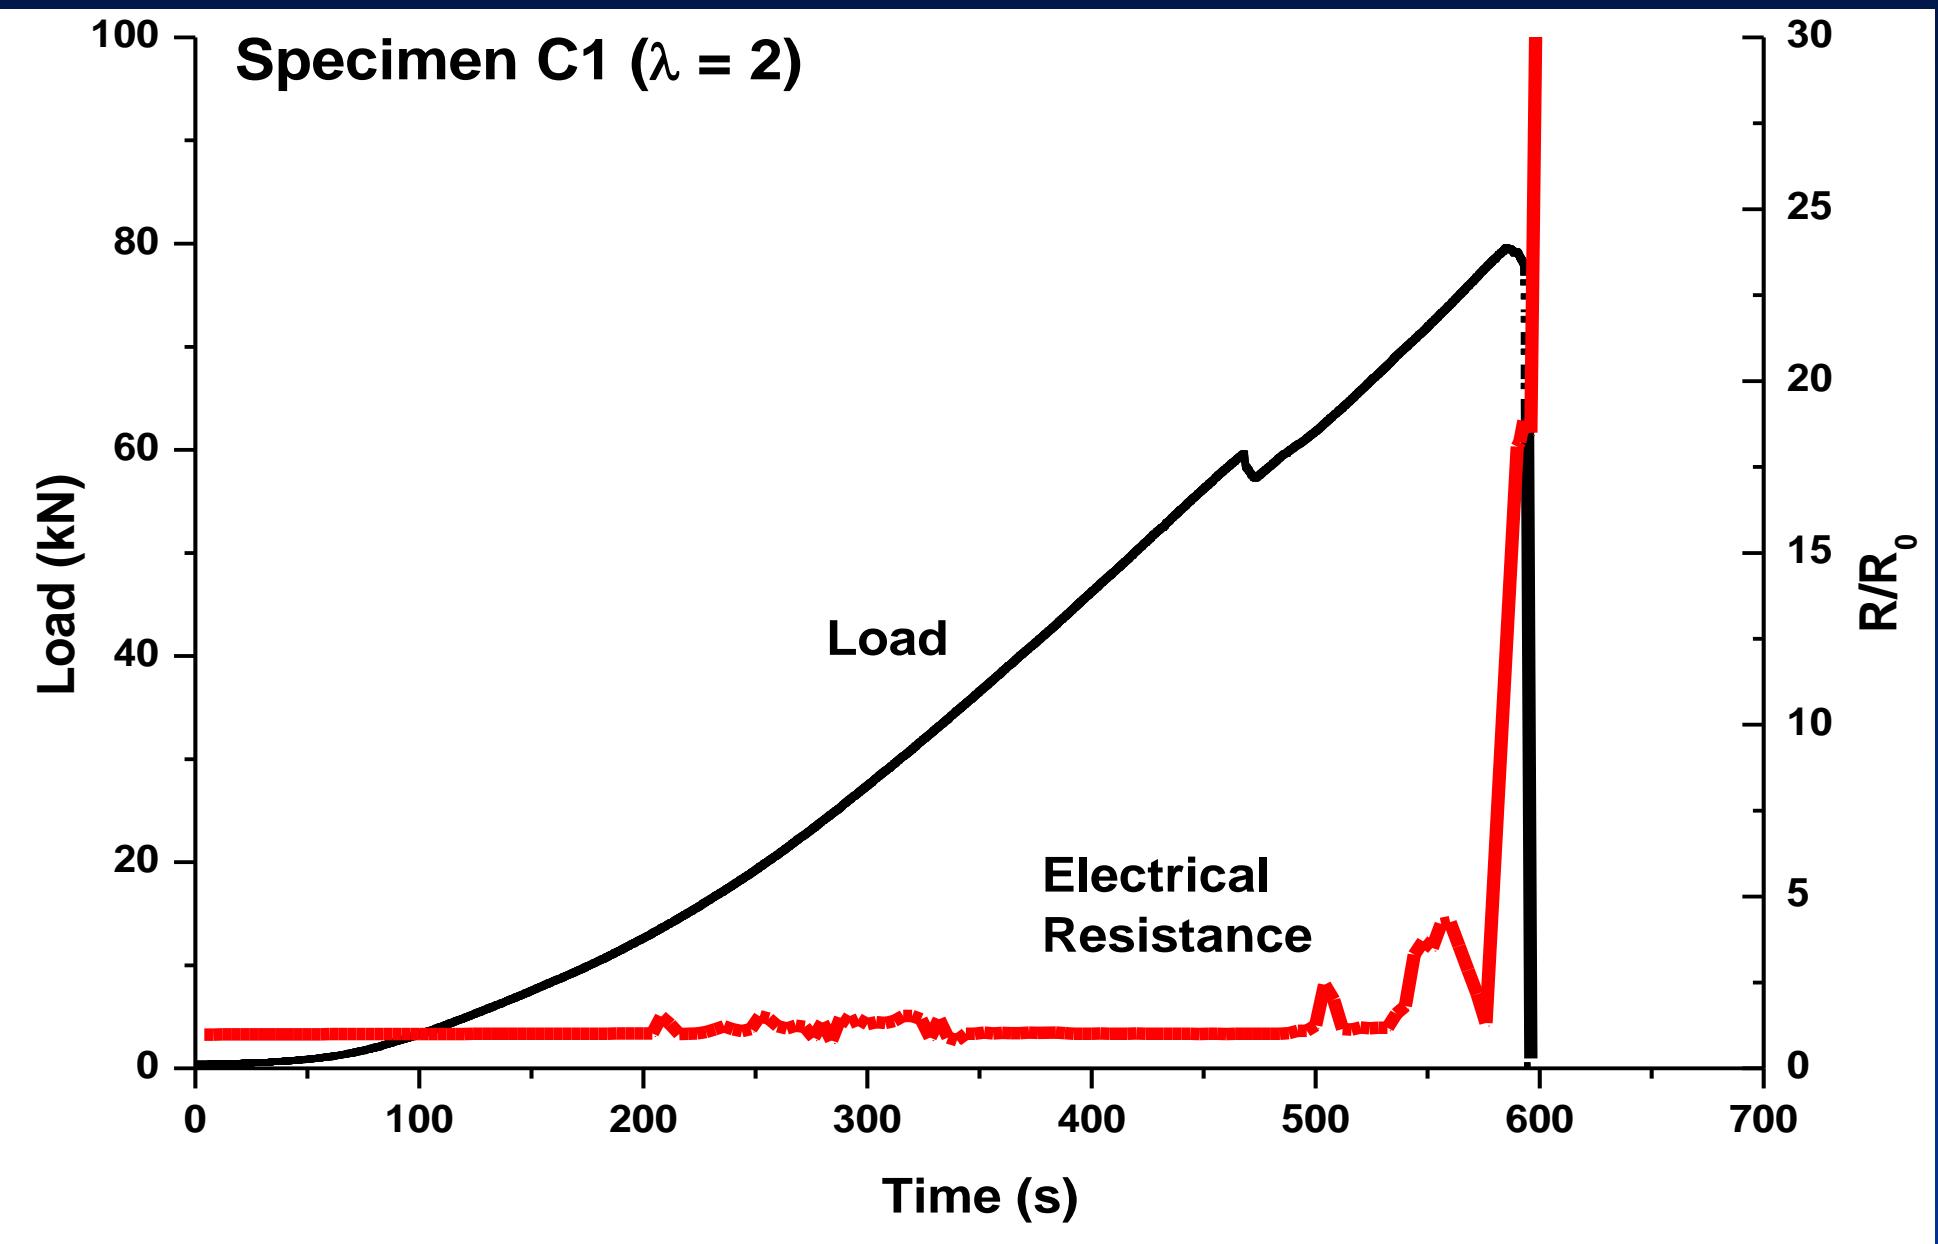
**Load vs. time diagram and relative electrical resistance (R/R_0) variation
for the prismatic mortar specimen C1.**
