Damage analysis of decorated surface structural support by the Acoustic Emission technique

Cappella XVII del Sacro Monte di Varallo

- (a) Indagine sulla stabilità degli intonaci affrescati e delle lesioni murarie con la tecnica EA
- (b) Analisi delle proprietà elettriche delle statue in terracotta

Risultati complessivi del monitoraggio condotto dal 28 aprile, ore 15.00, al 4 giugno, ore 12.00

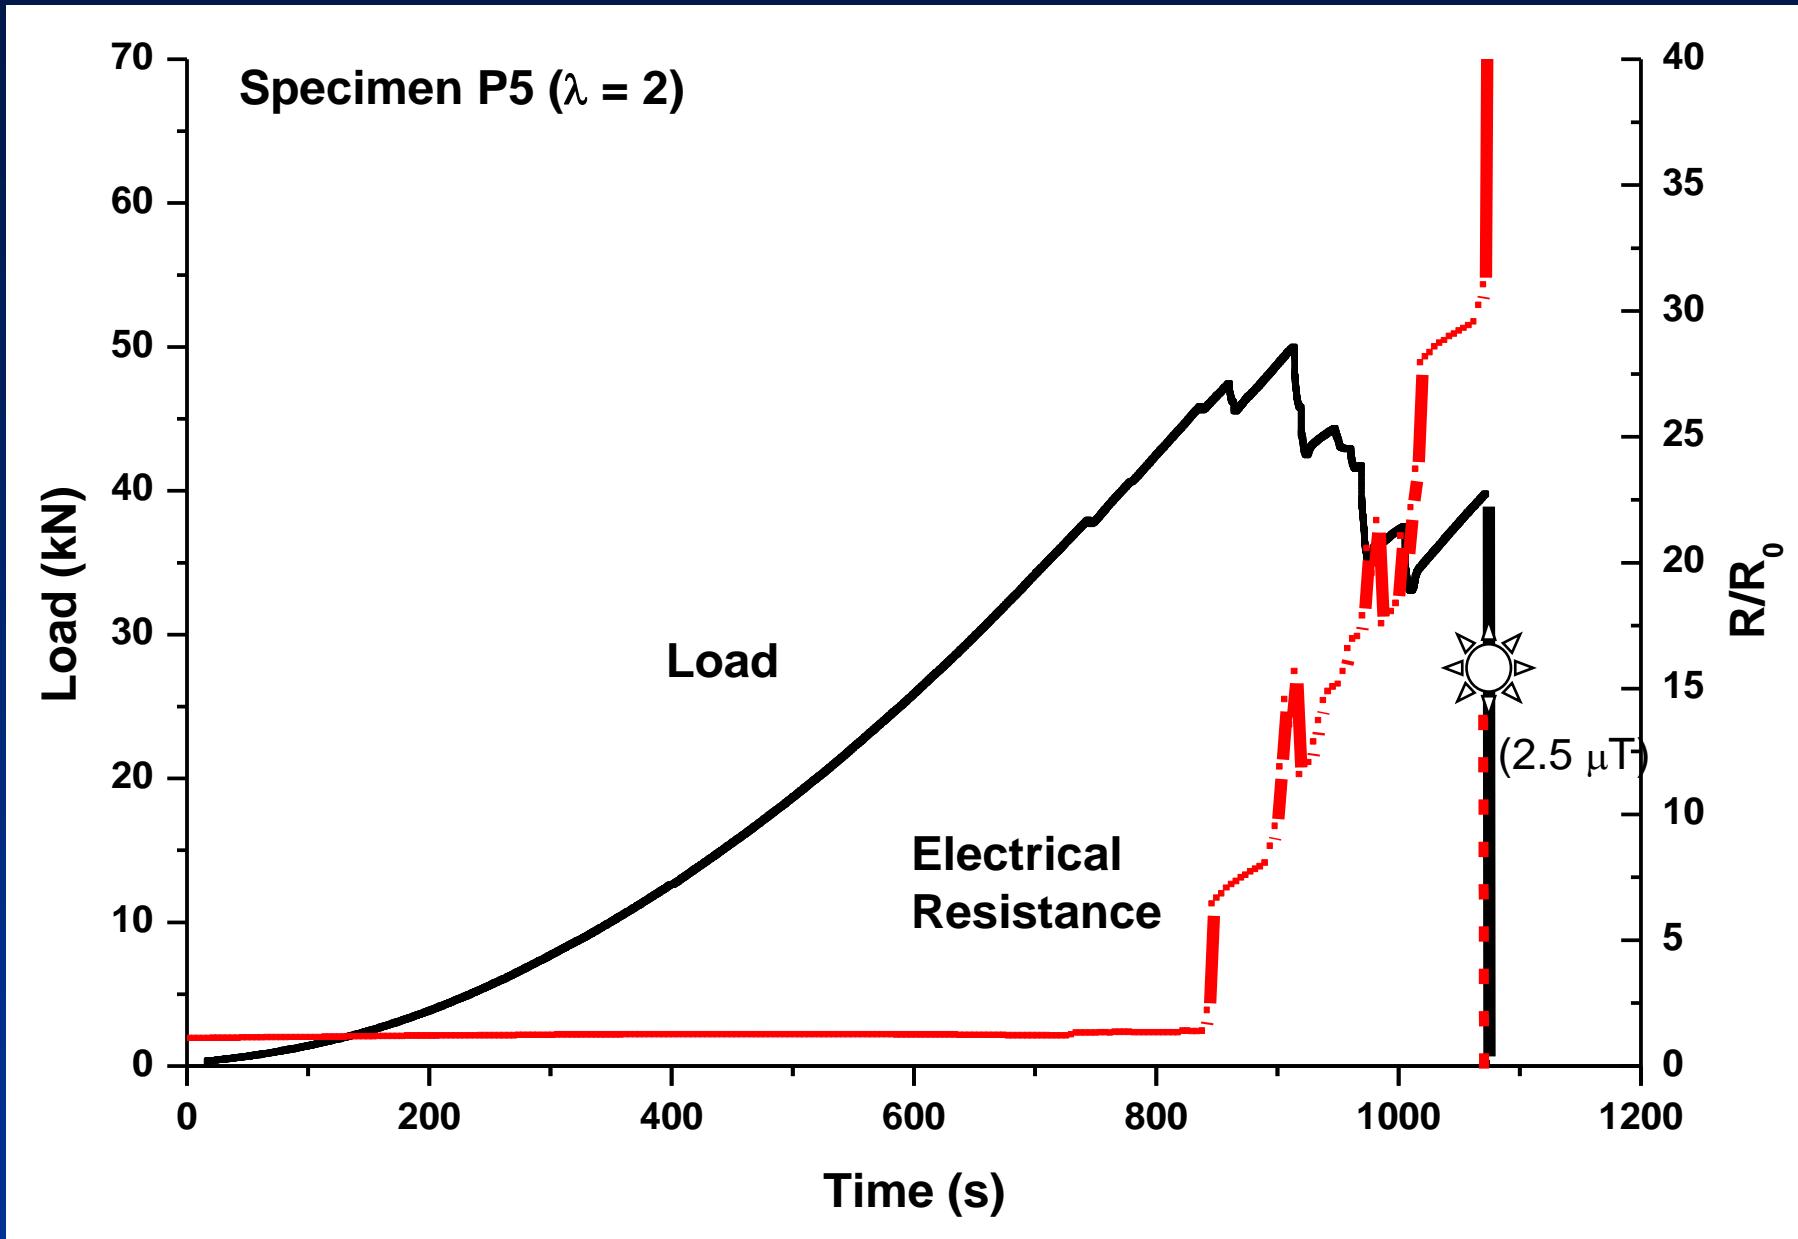
Load vs. time diagram and relative electrical resistance (R/R_0) variation for the cylindrical Green Luserna Granite specimen P5.

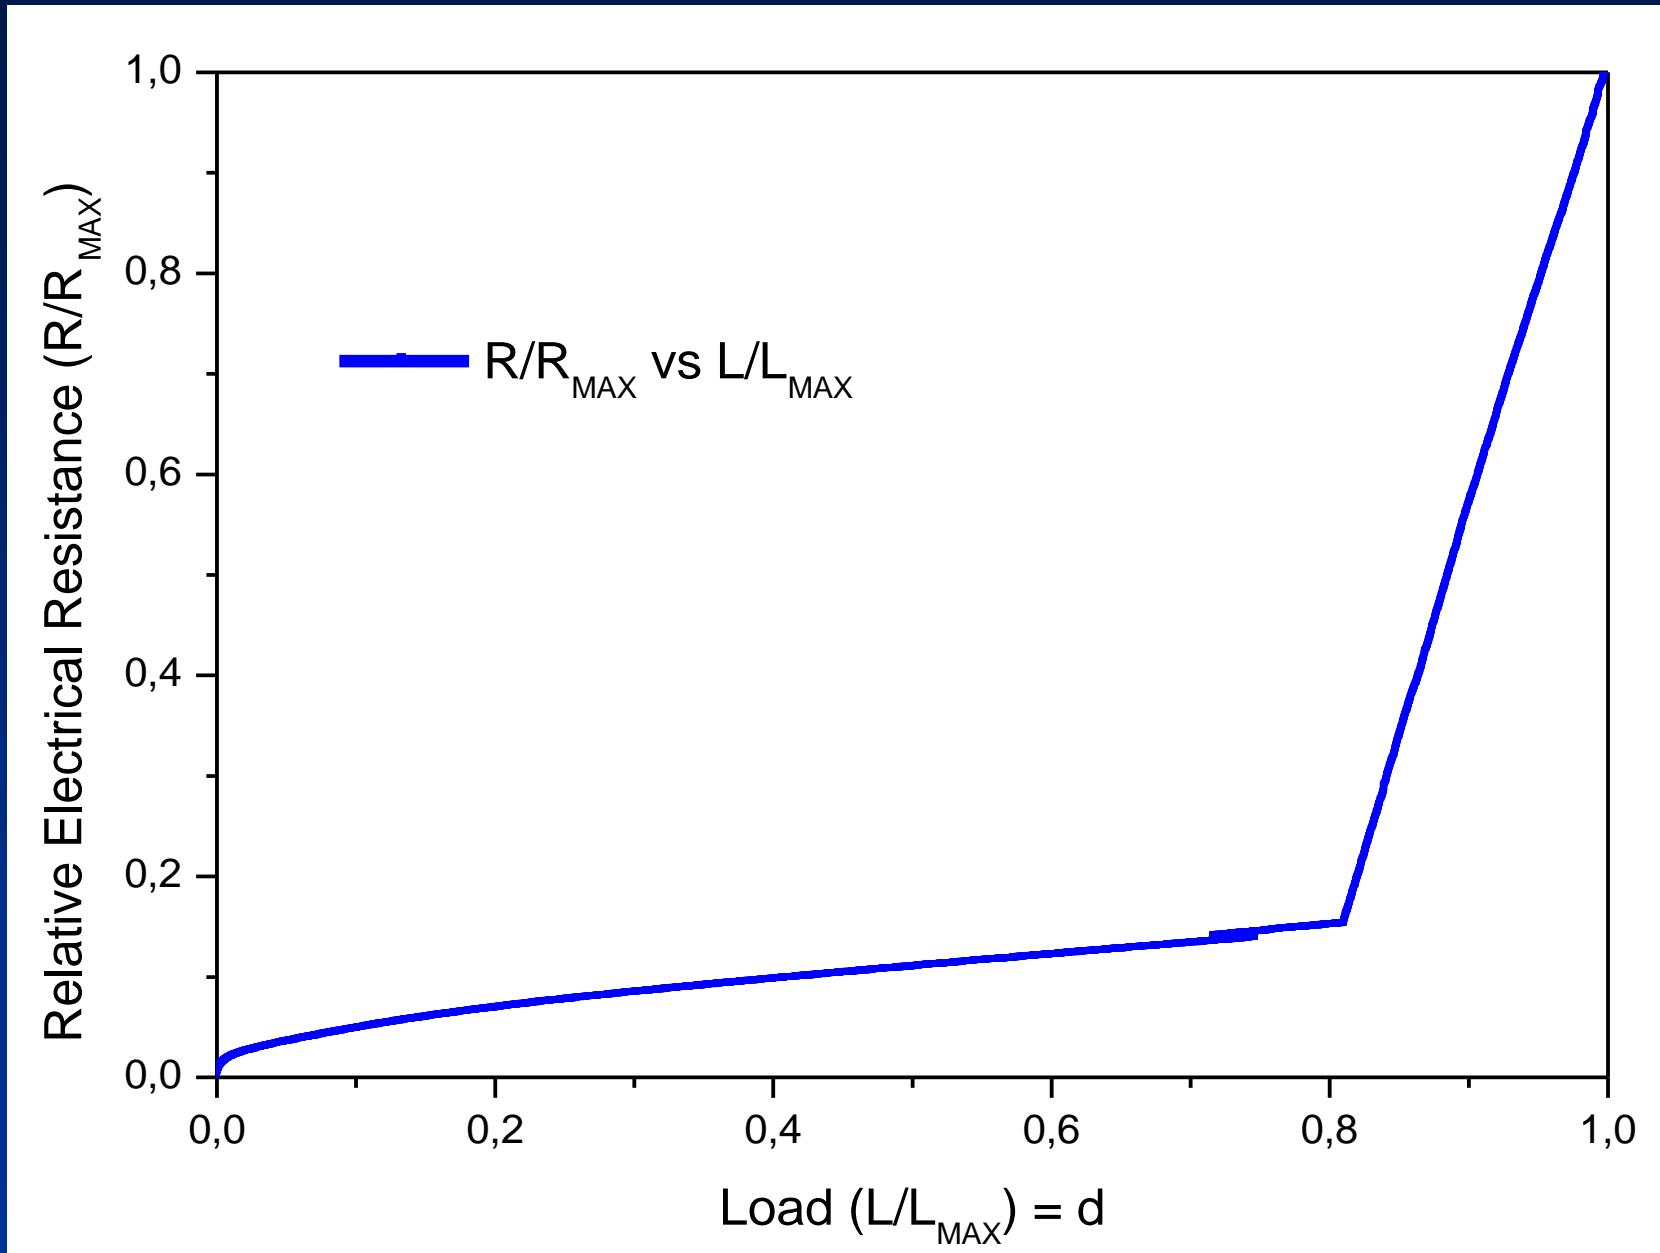
**Relative electrical resistance (R/R_{MAX}) vs damage variation (L/L_{MAX})
for prismatic mortar specimens.**

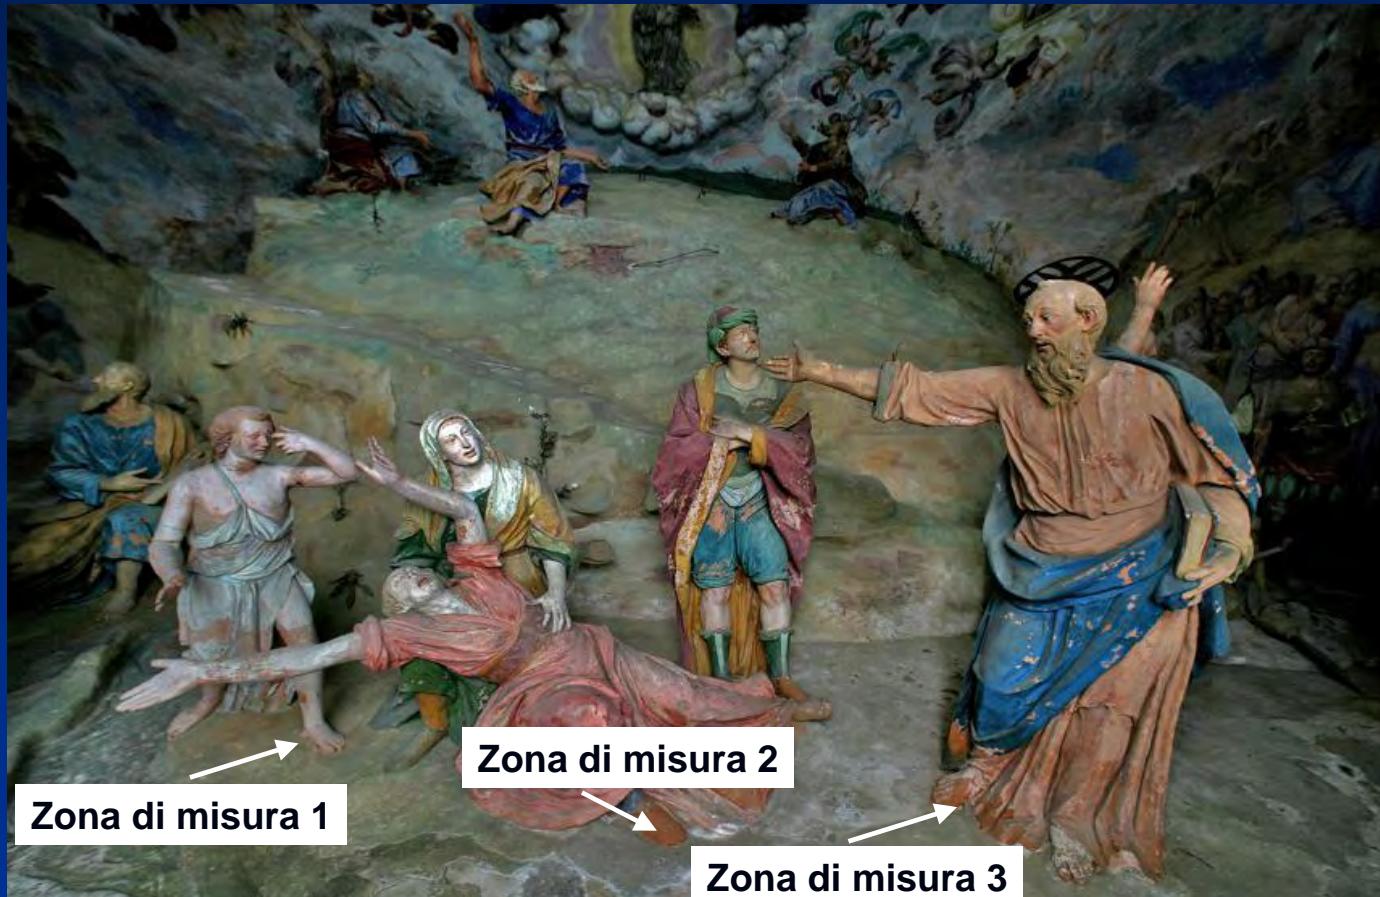
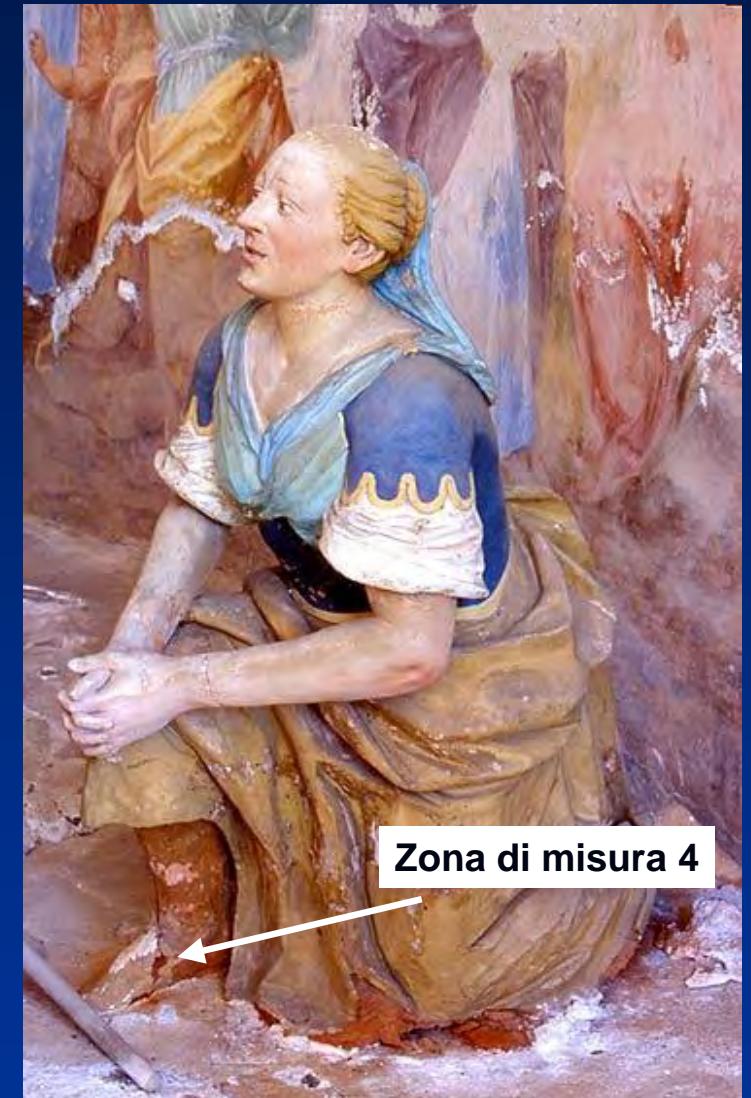
Livello di danneggiamento delle basi di appoggio delle statue
